## Recreational Pilot e-zine

Issue 101  
December 2015

#### **Defect report- Tecnam P92 nose gear failure**

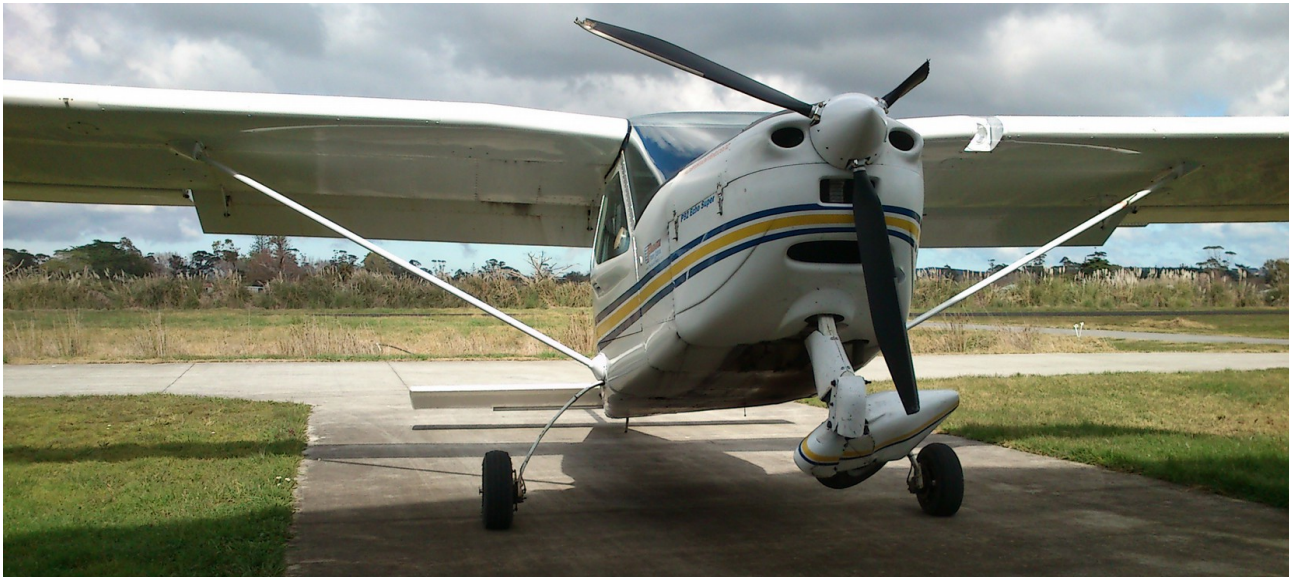
Propeller and nose leg damaged (see photographs 1 & 2). Nose Leg Fork Plate (RH) had broken at the shock absorber mounting bolt and the leg had collapsed backward (photograph 2).

*Photograph 1: Front View of Aircraft*

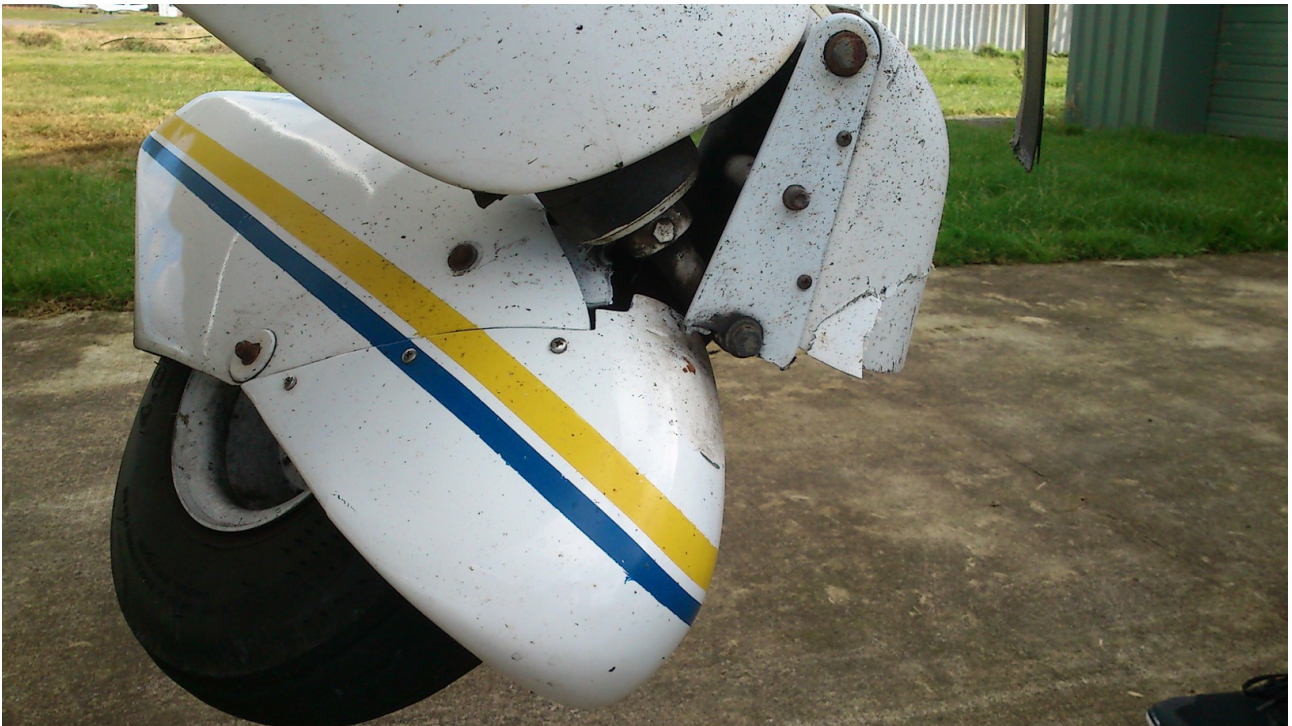
*Photograph 2: Detail of Collapsed Nose Leg*

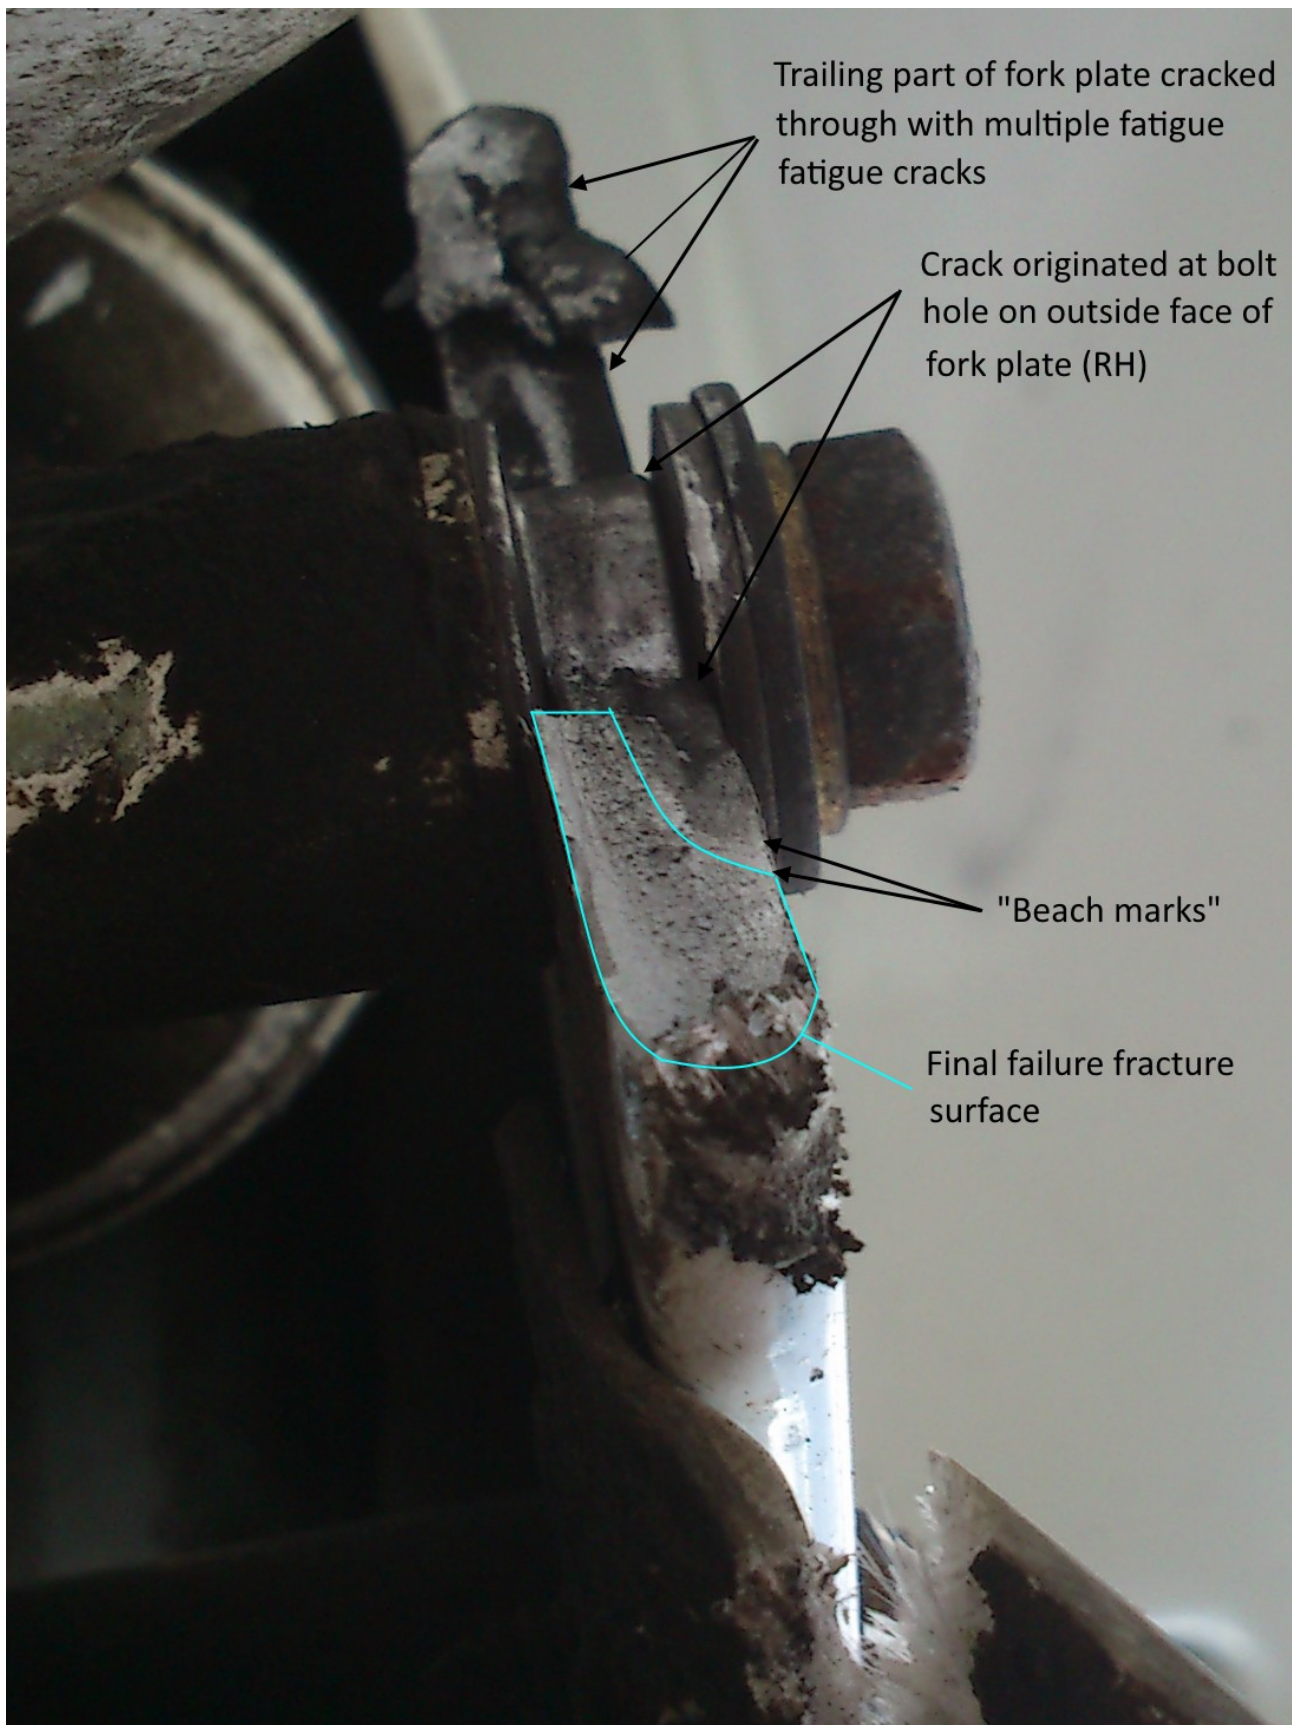
The Right Hand Fork Plate had failed through the bolt hole. Failure was through progressive fatigue, evidenced by thumbnail crack formation over time, with leading “beach marks” (photograph 4). The whole of the trailing section of the fork plate (i.e. that section behind the shock absorber mounting bolt hole) had fatigued through.

*Photograph 4: Fracture Features on Failed Fork Plate (RH)*

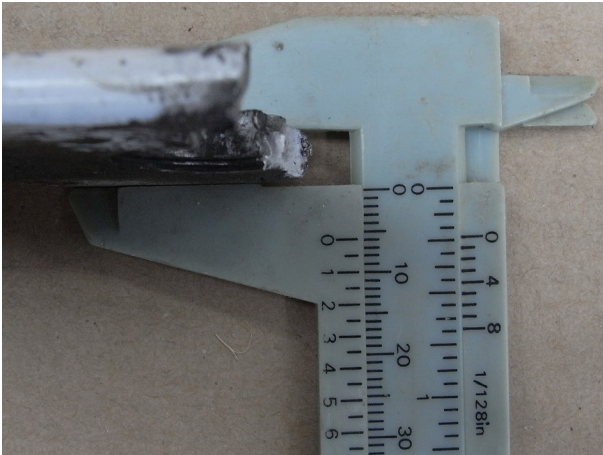
Further metallurgical analysis was not conducted. However, the dimensional details of the fracture surface are recorded in Photographs 5 to 10. Features of the failure can be seen in these photographs. Final fracture of the fork plate occurred when approximately 70% of the available load bearing cross sectional area had already cracked through due to fatigue.

*Photograph 5: Thickness of failed Fork Plate (~6.1 mm)*

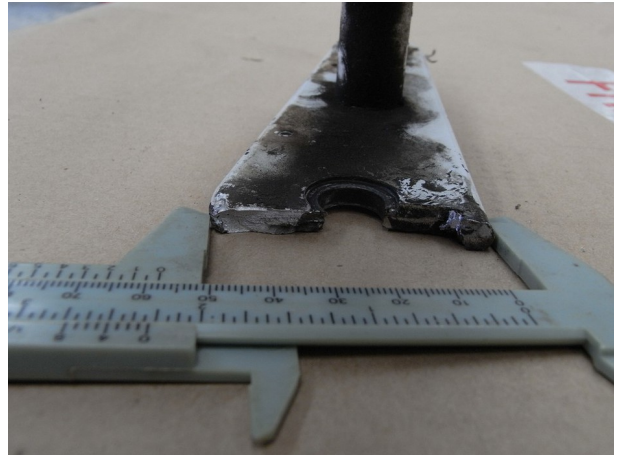
*Photograph 6: Total Width of Fork Plate – note fracture surface features*

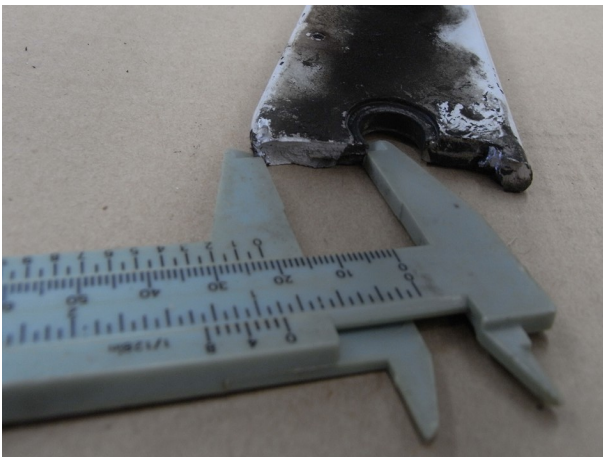
*Photograph 7: Leading Section Width (Final failure section)*

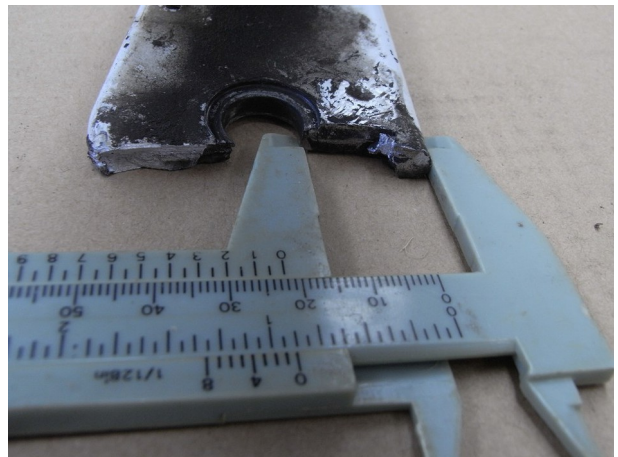
*Photograph 8: Trailing Section Width (this section was fatigued completely prior to final failure)*

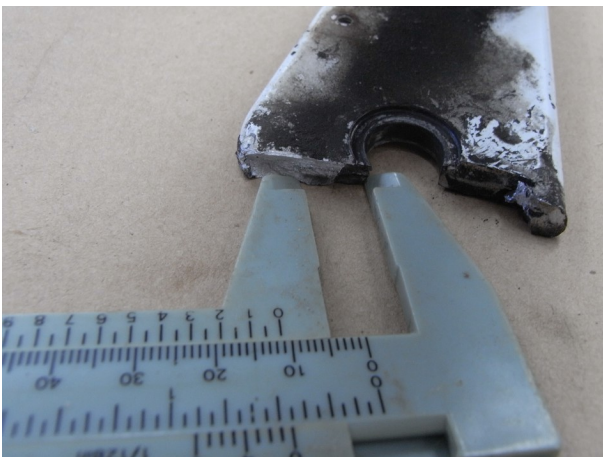
*Photograph 9: Thumbnail Crack Width*

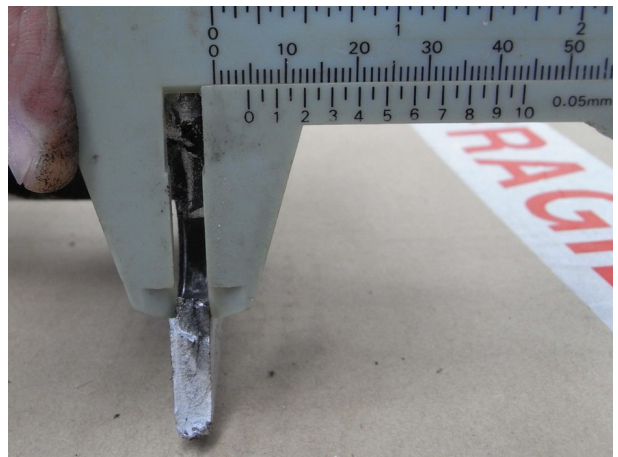
*Photograph 10: Thumbnail Crack Thickness*

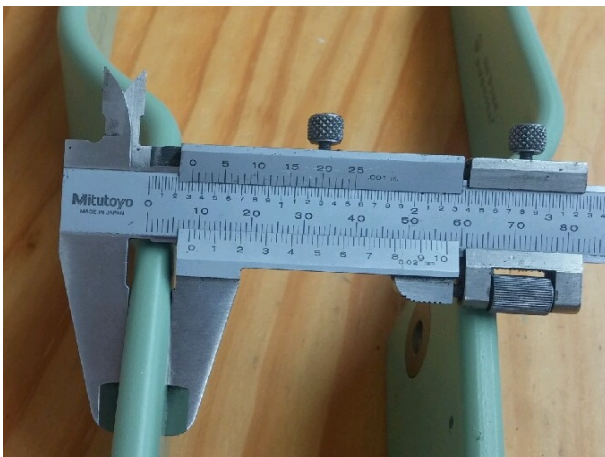
The replacement fork plates ordered to repair the damaged nose leg on ZK-CDL are 2 mm thicker (i.e. 8mm instead of 6mm) and the bushes for the shock absorber attachment bolt have been re-engineered (Photographs 11 & 12). Given the same load bearing width, this would increase load carrying area by 33%, or reduce the stress due to normal operations by a similar degree.

*Photograph 11: Replacement Fork Plate Thickness (~8.1 mm)*

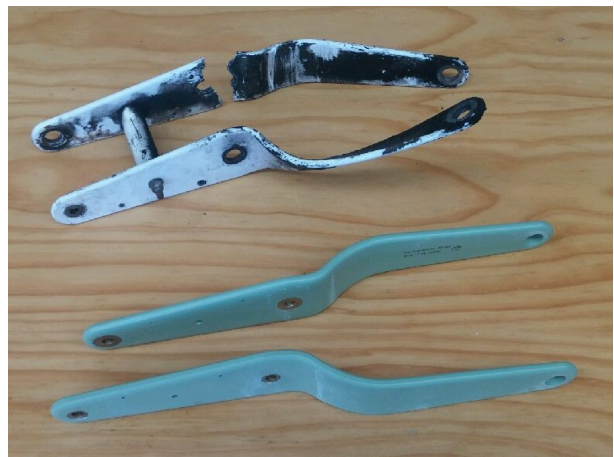
*Photograph 12: Replacement Fork Plate General View – Note Bushing in Central Hole on new plates*
