Recreational Pilot e-zine

Issue 115
February 2017

Mandatory Action Jan. 2017

Inspection of the Horizontal Stabilizer tail attachment brackets

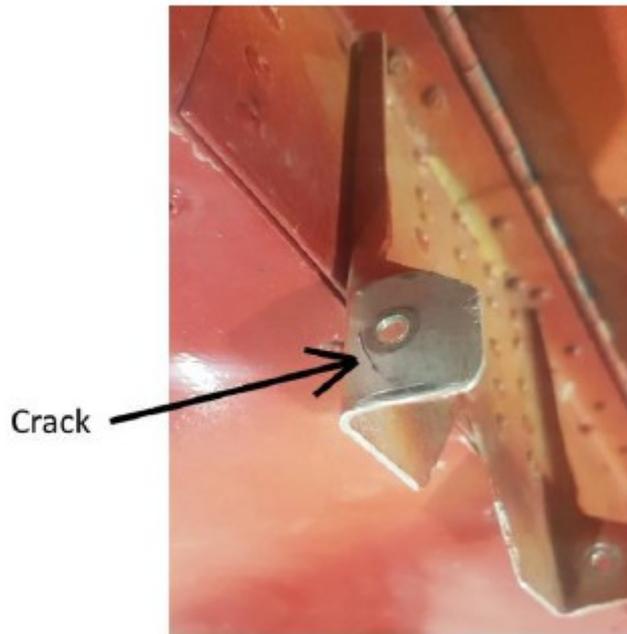
Crack

View of H.S. rear attachment bracket. A crack is developing in the part. Part must be replaced.

Replace parts that do not match the aircraft airframe blueprints (drawings). Replace parts that have been drilled or assembled incorrectly. The H.S. must fit snug to the fuselage fittings. Bolts when tight must not bend the H.S. fittings. Correct type rivets must be installed properly as per the design standards manual. If you did not assemble your airframe, hire a certified aircraft mechanic to complete this task. Log book entry must be made. When reinstalling, use new AN bolts and self locking bolts. Torque them as per AC 43-13 1B and 2B. Do not over tighten the bolts. Once installed, check control cable tensions, all connections, interferences, etc. See http://www.newplane.com/Service_Letters_Bulletines/Control%20cable%20tensions%20Zodiac.pdf

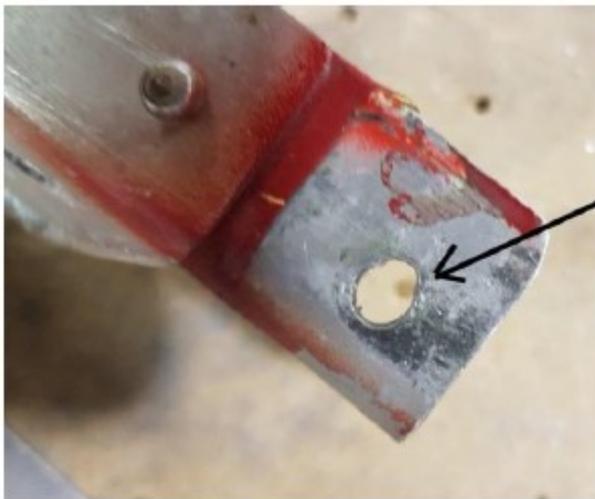
Strange hole.
Part must be changed.

View of H.S. front attachment bracket. Bolt hole was not properly drilled. Part must be replaced.

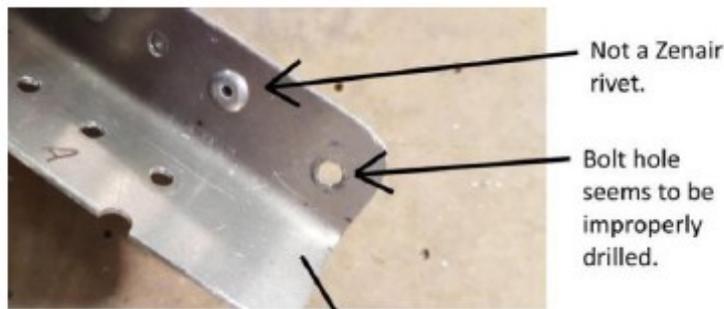
Not a Zenair rivet.

Bolt hole seems to be improperly drilled.

Bracket attaching horizontal stabilizer to fuselage.
This is not an original bracket.

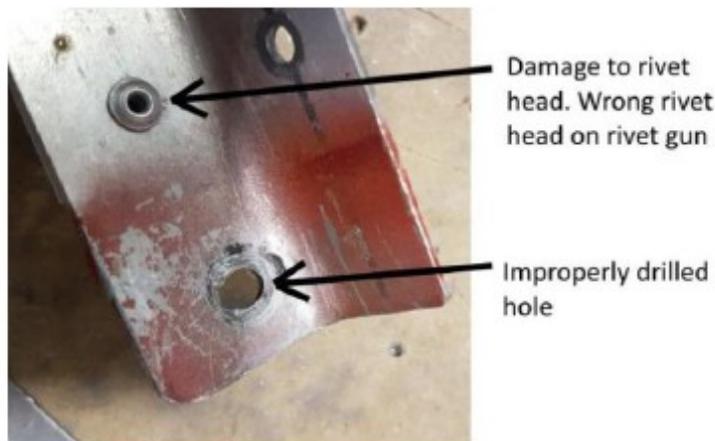
Damage to rivet head. Wrong rivet head on rivet gun

Improperly drilled hole

Above parts must be replaced.

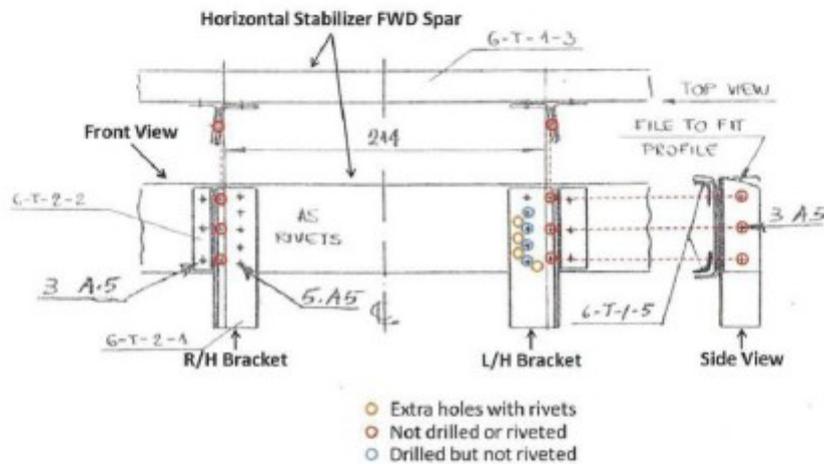
Figure 1. Horizontal stabilizer forward structural attachment—aircraft drawing. (source: Zenair, with digital annotations by the TSB)

As per the drawing (Figure 1), the horizontal stabilizer forward structural attachment is designed to be constructed by riveting two aluminium angles (attachment bracket 6-T-2-1 and attachment doubler 6-T-2-2) with three rivets back-to-back and connecting the attachment bracket to the front surface of the forward spar (6-T-1-3) with five rivets.

In the actual installation, the three rivets connecting each attachment bracket to the associated attachment doubler were missing and the required holes were not drilled. Four additional holes were drilled through the left attachment bracket and continued through the forward spar. Rivets were installed in all of these additional holes; however, they were only installed in one of the five holes specified in the drawing.

Structural integrity of the horizontal stabilizer forward attachment point was compromised on both sides because of the missing rivets, and the strength of the forward spar itself was reduced because of the extra holes.
