Recreational Pilot e-zine

Issue 156
August 2020

Defect report- Sonex/AeroVee engine

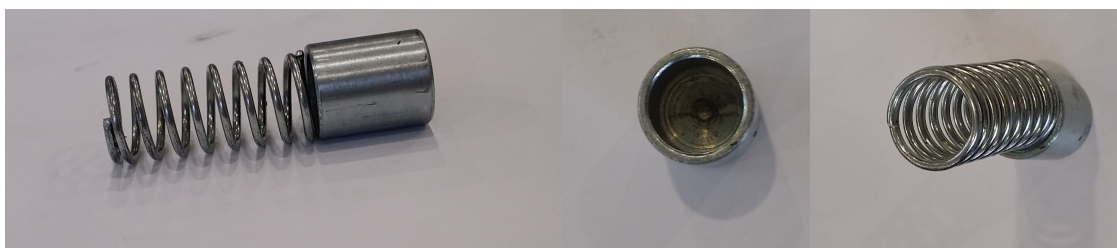
Microlight type/model	Sonex
Place of incident	NZMA
Other aircraft involved	None
Describe the incident	<p>On the 10th July I was in the process of performing a ground run at the hangar to adjust / calibrate <u>EFIS</u> and carburetor mixture <u>AeroVee</u> engine . Followed the startup procedure , turned engine over however it would not start. Opened the throttle slightly more and tried again. Engine started , switched <u>EFIS</u> on . Oil pressure <u>38psi</u> due to the cold weather set throttle at <u>1500rpm</u> to obtain smooth running . During the warm up at idle speed the oil pressure momentarily dropped to <u>25psi</u> and came back up to <u>38psi</u> . After about 10 minutes running during calibration of the <u>EFIS</u> the oil pressure dropped to zero . Immediately switched off . Upon inspection found that the oil filter seal had blown out just enough to allow a oil leak but still have some oil pressure.</p>

Describe the affect on safety	<p>This could have resulted in a forced landing if it occurred before flight .</p>
Remedial action taken	<p>Removed the engine and dismantled to find the cause. Found that the pressure relief valve spring is <u>1mm</u> smaller in diameter to the piston and pushed over to one side . The relief piston is hollow with the flat side toward the case seat , the spring therefore sits on-top of the bottom piston skirt. Due to the fact that the spring is a slightly smaller diameter is is possible for the spring to move to one side .Uneven pressure will be applied to the piston creating friction against the case. I have also purchased new springs for the pressure relief valve as well as for the oil cooler bypass valve . No damage to internal engine components . The filter used is a <u>Fram PH8172</u> with relief valve, as recommended by <u>Sonex</u> . Recommended oil used is <u>20w50</u> .</p>

From these figures you can see that the spring only has 1mm seating area . With the spring OD 15 mm and bore ID 16mm we can assume that spring could easily shift to one side and theoretically only applying pressure to part of the plunger. This could place additional friction against the case wall causing a pressure spike .

Corrective or preventive action recommendations	<p>I am in the process of making a dowel that will locate into the relief piston and spring to centralize the spring . Keep the engine speed as slow as possible immediately after start-up. Possibly start with <u>EFIS</u> switched on to see if there are pressure spikes. Pictures to follow.</p>

Some have machined plunger inserts to centralise the spring . I personally think this is not a good idea as there is no way to permanently secure an insert in the plunger . What I have found is that an OE part plunger has a thicker wall than the aftermarket plunger-
