Recreational Pilot e-zine

Issue 53
December 2011

ALERT SERVICE BULLETIN

ASB-912-059UL
ASB-914-042UL

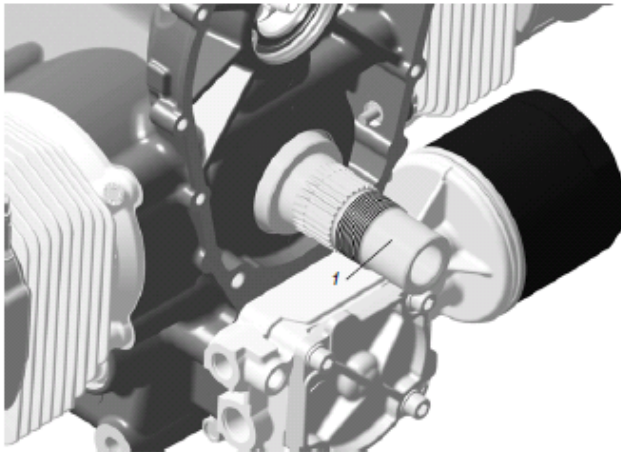
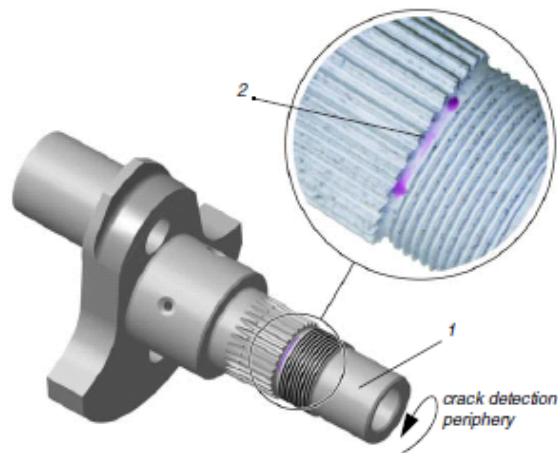
Fig. 1
crankshaft journal

Due to a deviation in the manufacturing process some crankshafts may have a crack formation occur on the power take off side. These cracks can cause a breakage of the crankshaft support bearing and may lead to engine stoppage.

6. Unlock the crankshaft to do the check on the entire periphery of the crankshaft.
 - Detailed crack detection in the area (2) of the thread runout using penetration test. Perform this test in accordance to the requirements of the applicable aviation authority in your region for non destructive testing (NDT) and according to DIN EN 571 or equivalent.

- 1 crankshaft
- 2 detailed crack detection

- **CAUTION:** In case of crack or doubt contact your aircraft manufacturer and your nearest authorized ROTAX aircraft engine distributor. The engine must not be taken into operation until the cause has been identified and eliminated.

7. If no cracks can be found, then the reassembly has to be conducted in accordance with following steps:
