Defect report- CH601 wheel spat bracket fail

Zenair
CH601
not specified
Graeme Sherrard
August 2014

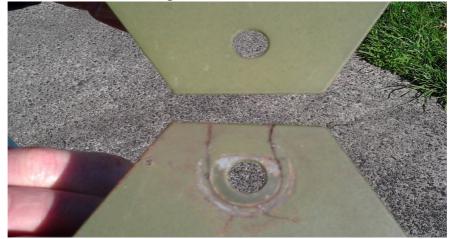
Defect: Spat was found to be loose.

On disassembly and close inspection, one bracket was found to have a crack- initiated by the sharp edge of a washer creating a stress raiser, with the crack propagating neatly around the washer circumference and out to the bracket edge.

Stamped washers have a **rounded** edge on one face, and a **sharper** edge on the other from the press forming. When fitting it is advisable to ensure the **rounded** edge is against any light or flexible the base material to avoid stress raisers.
