Internal Report: Tecnam P92 ES (ZK-CDL) Nose Leg Failure – 25/07/2015

Summary

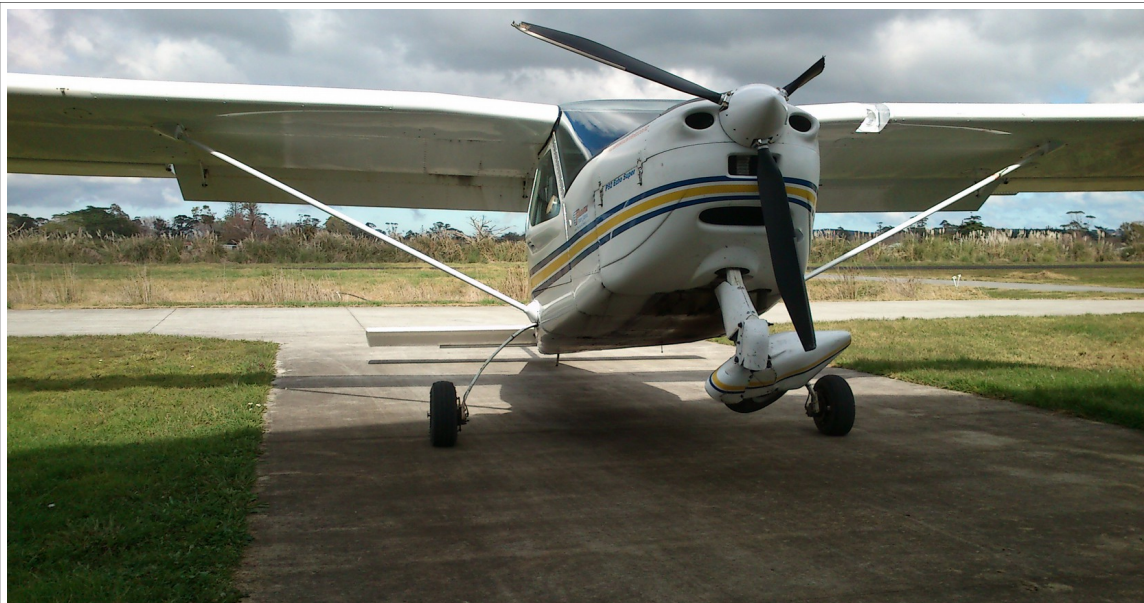
Propeller and nose leg damaged (see photographs 1 & 2). Nose Leg Fork Plate (RH) had broken at the shock absorber mounting bolt and the leg had collapsed backward (photograph 2).

Photograph 1: Front View of Aircraft

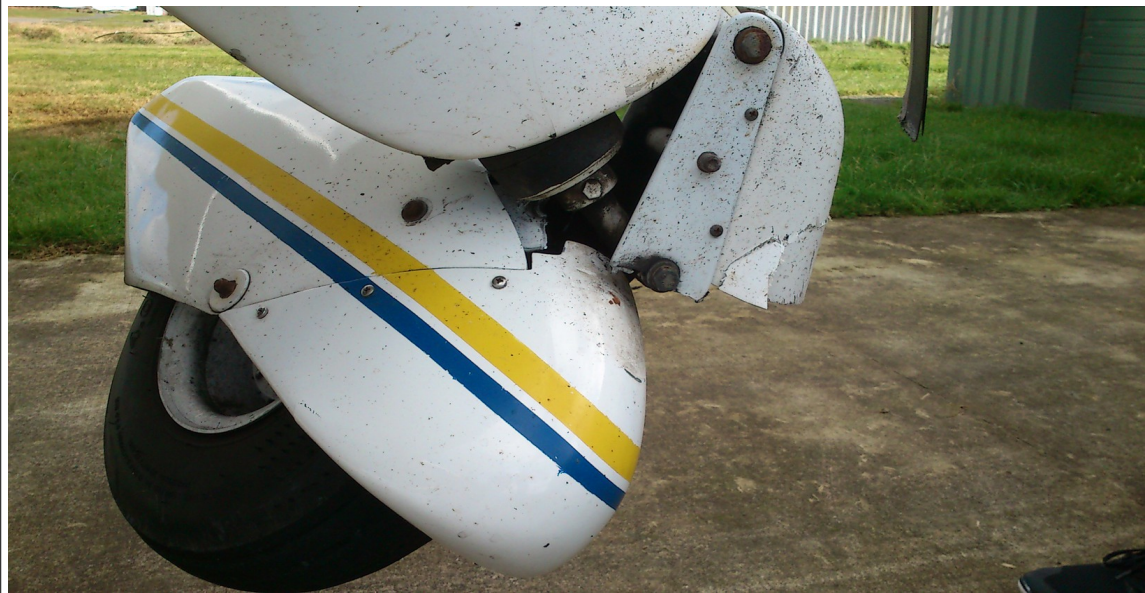
Photograph 2: Detail of Collapsed Nose Leg

The Right Hand Fork Plate had failed through the bolt hole.

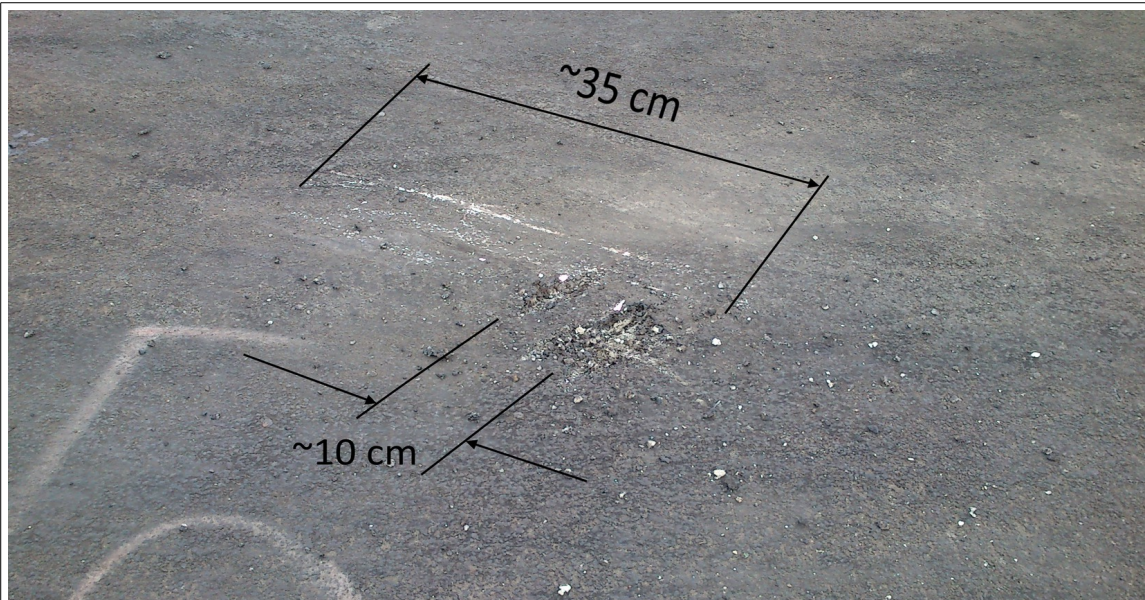
The aircraft left a skid mark and two divits (from the propeller blade strike) in the runway as shown in Photograph 3.

Photograph 3: Skid mark and damage to runway

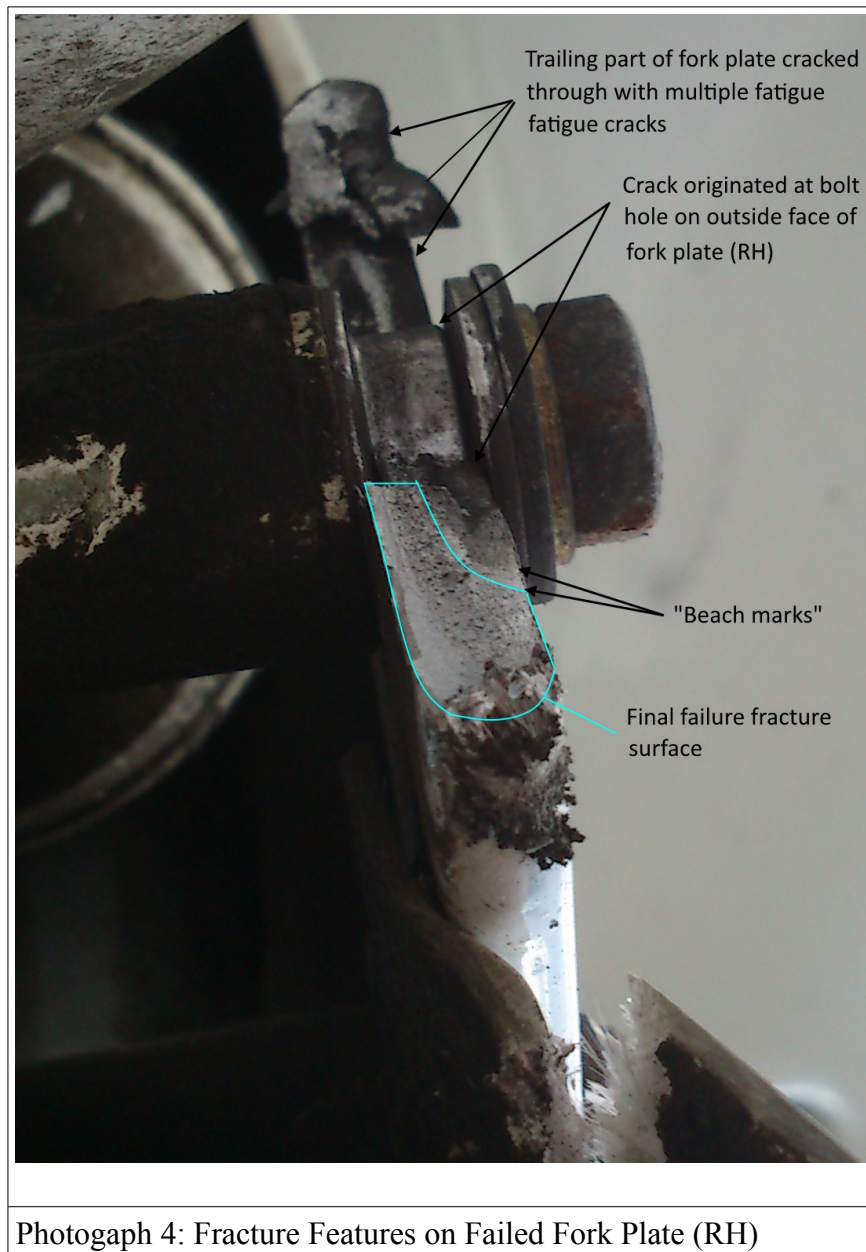
Failure was through progressive fatigue, evidenced by thumbnail crack formation over time, with leading "beach marks" (photograph 4). The whole of the trailing section of the fork plate (i.e. that section behind the shock absorber mounting bolt hole) had fatigued through.

This indicates a fatigue through torsional loading, with the highest loads being experienced by the material at the rear of the fork plate, around the mounting bolt hole.

Photograph 4: Fracture Features on Failed Fork Plate (RH)

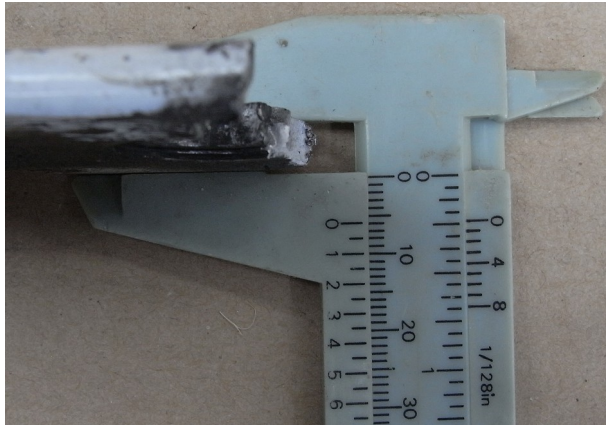
Further metallurgical analysis was not conducted. However, the dimensional details of the fracture surface are recorded in Photographs 5 to 10. Features of the failure can be seen in these photographs. Final fracture of the fork plate occurred when approximately 70% of the available load bearing cross sectional area had already cracked through due to fatigue.

Photograph 5: Thickness of failed Fork Plate (~6.1 mm)

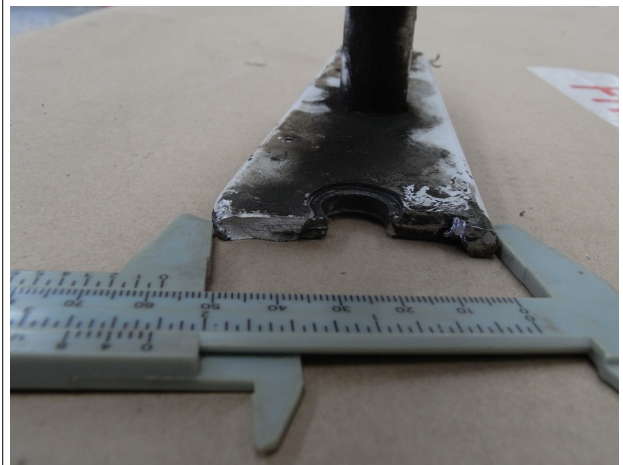
Photograph 6: Total Width of Fork Plate – note fracture surface features

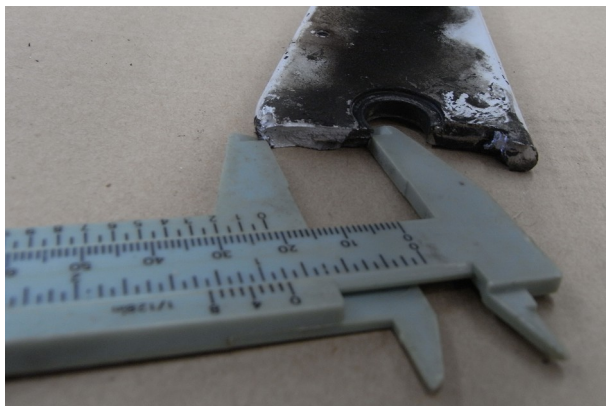
Photograph 7: Leading Section Width (Final failure section)

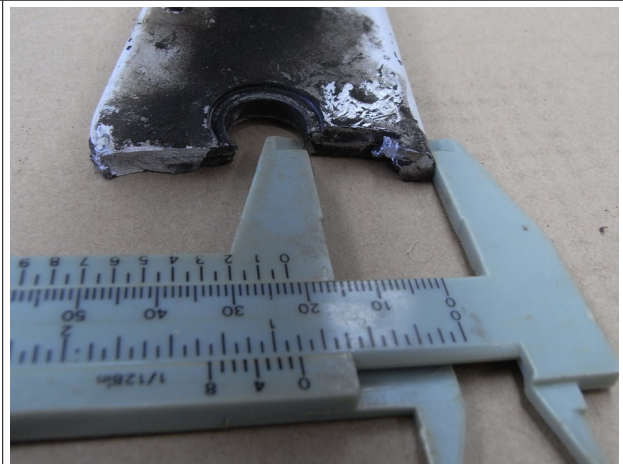
Photograph 8: Trailing Section Width (this section was fatigued completely prior to final failure)

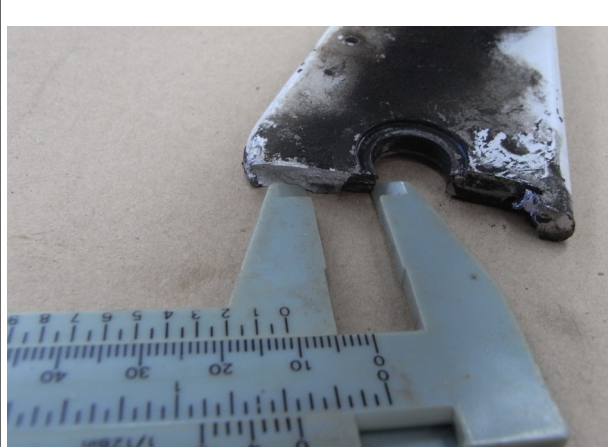
Photograph 9: Thumbnail Crack Width

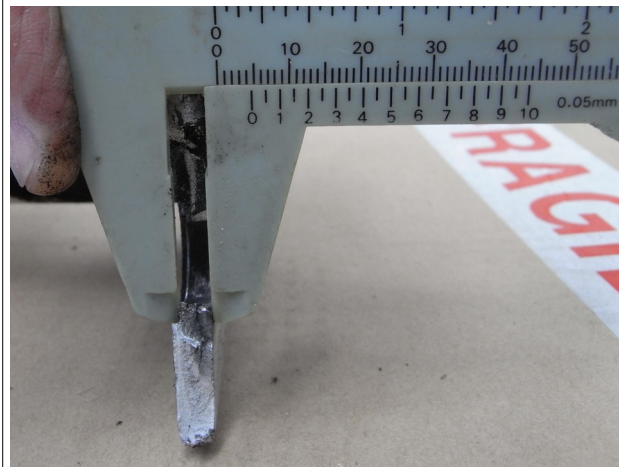
Photograph 10: Thumbnail Crack Thickness

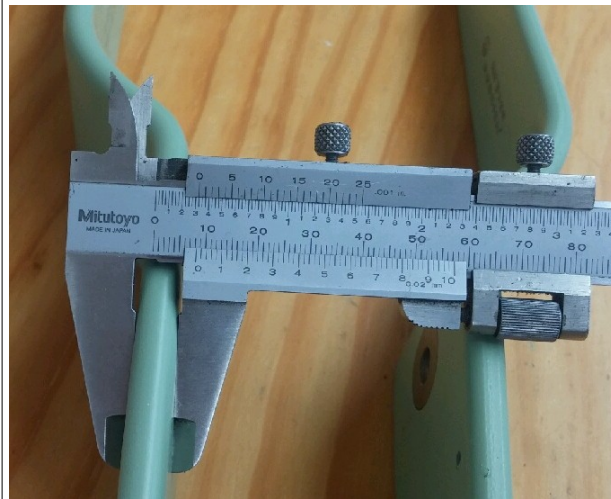
Photograph 11: Replacement Fork Plate
Thickness (~8.1 mm)

The replacement fork plates ordered to repair the damaged nose leg on ZK-CDL are 2 mm thicker (i.e. 8mm instead of 6mm) and the bushes for the shock absorber attachment bolt have been re-engineered (Photographs 11 & 12). Given the same load bearing width, this would increase load carrying area by 33%, or reduce the stress due to normal operations by a similar degree.

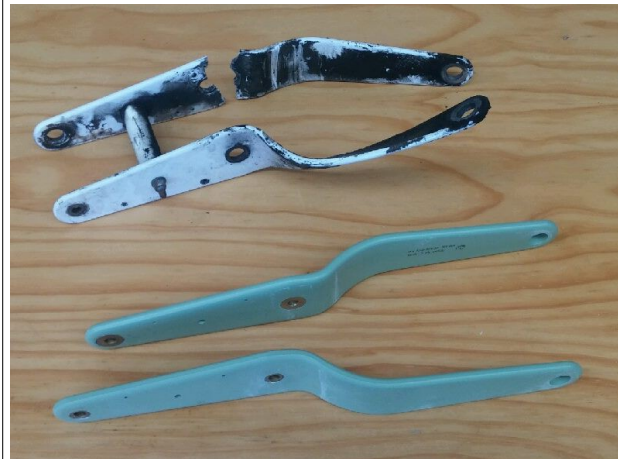
Photograph 12: Replacement Fork Plate
General View – Note Bushing in Central Hole
on new plates
