From: "Paul Parsons" <minicabzkczt@yahoo.com.au>
Date: Tuesday, 6 October 2015 9:57 PM
To: "RAANZ Admin" <office@raanz.org.nz>
Subject: Fw: Foxcon 200. (photos)

Sent: Sunday, 4 October 2015, 17:48
Subject: Foxconn 200. (photos)

Subject: Foxcon 200 maintenance

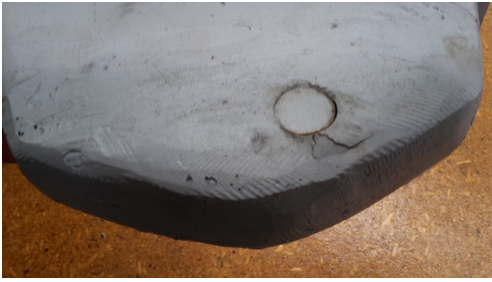
- (1) Loose upper bell crank and fractured f/glass mounting box and poor quality f/glass work.
- (2) Hole worn in f/glass box and distorted bell crank arms.
- (3) No.2 from a different angle. Note the rivets with some piece missing - I have no idea what it was.
- (4) Different view of loose bellcrank and fractured f/glass box.
- (5) Another view as in (4).
