## Defect Details

Microlight type/model Xair Hanuman MMC

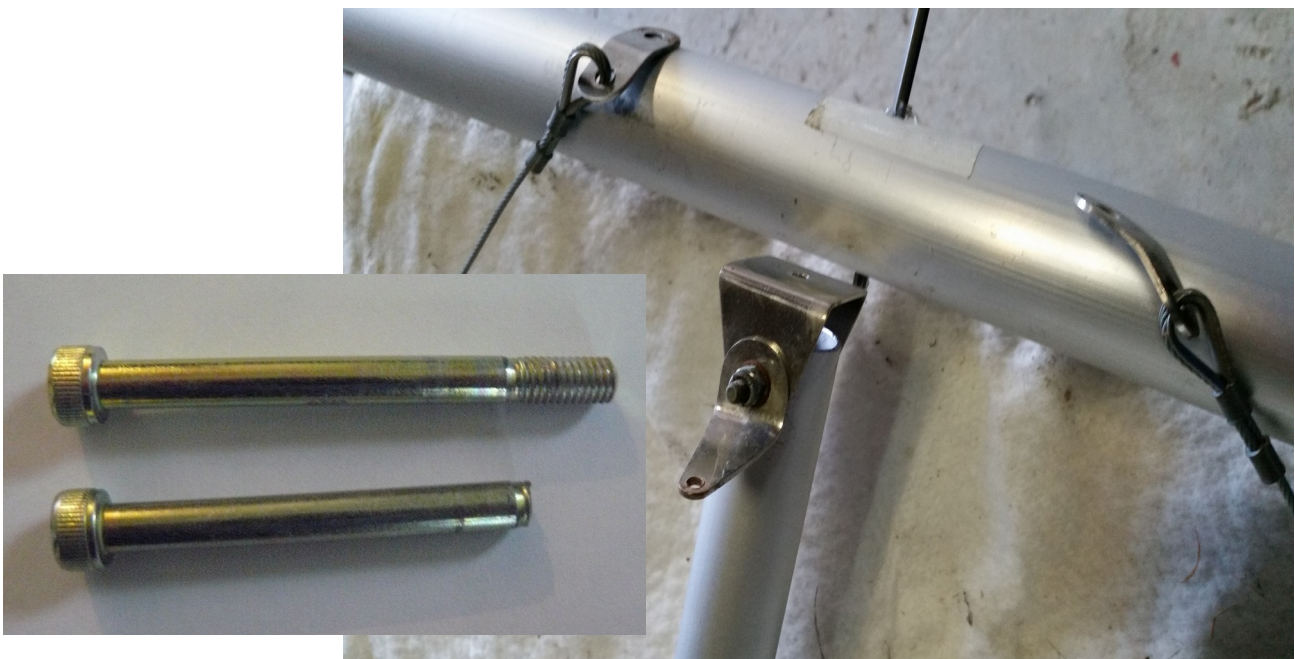
Describe the defect Issue found during a pre flight. Inboard Port rear brace wire and drag link attachment bolt broken at point of shank and thread. The bolt is a cap screw marked TVS 12.9. It would appear that during initial assembly the nut and washer have been wound up hard against the shank. Bolt has broken leaving inner brace and wires floating.

Describe the affect on airworthiness Starboard wing subsequently removed and cover stripped for inspection. Bolt and nut found to be done up to a similar level of tension with obvious signs of marking

Remedial action taken Caps screw on both wings replaced with a slightly longer version allowing washers to be used as packers and spacers reducing drag wire tension slightly and allowing for the nut to be done up correctly without bottoming out on the shank.
