Recreational Pilot e-zine

Issue 80 March 2014

Defect Report

Make: RANS Coyote

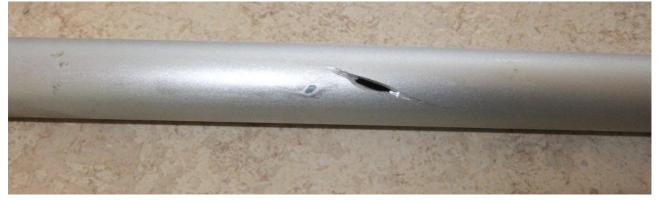
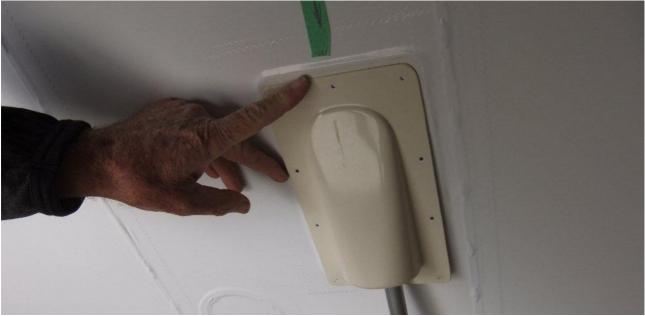
Both aileron push-rod tubes damaged due to wing cover plate screws rubbing on tubes. One has worn right through tube.

It is easy to inspect both ends of these push-rods but overlook the middle.

When worn right through the tube, the screw could then lock the tube from full and free movement.

Inspection of another S6S revealed the same defect.

Removed and replaced push-rods Left the middle cover retaining screw out.

- 1. Remove cover and inspect before further flight.
- 2. Replace any rods with evidence of wear.
- 3. Do not fit the middle cover retaining screw- it is well retained with the remaining screws.
