# **Recreational Pilot e-zine**

lssue 154 June 2020

# Defect report- MTO Sport wiring Peter Blaymires

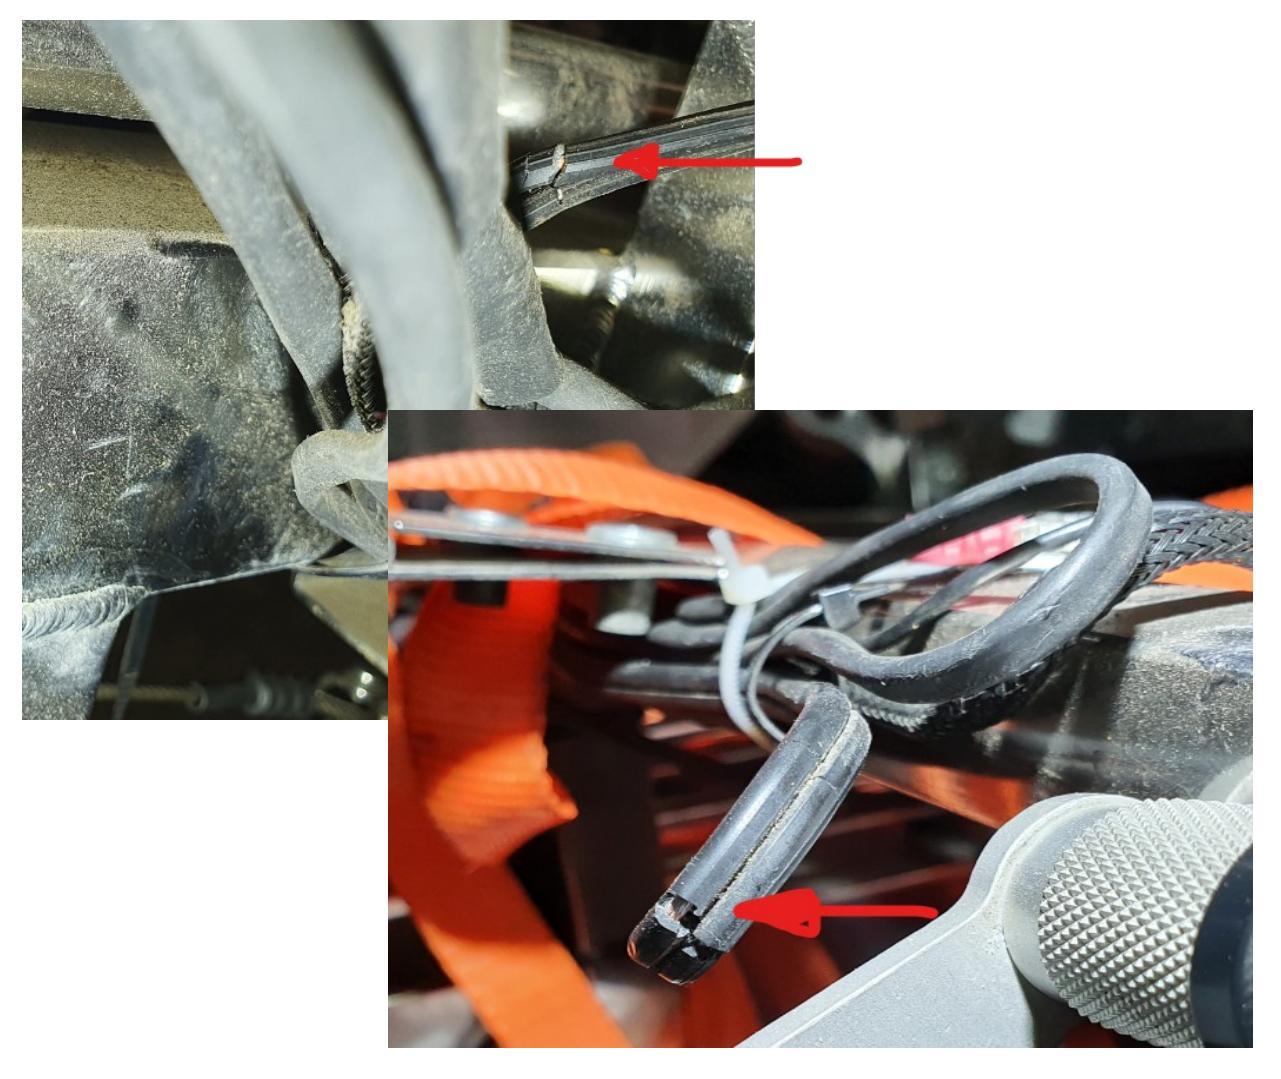
I found cracking in the auxiliary wires yesterday for the heated jackets on TCG. They are the only wires that I can see a problem with.

"I have got the fairings off my Autogyro at the moment and have been giving it a detailed inspection. I have found cracking on the wires to the auxiliary plugs for the heated jackets. For some reason Autogyro have used a rubber cable for this only. It's perishing, and bare wires are showing. I cannot find any issues with other wires.

It can be isolated at fuse F6 20amp I believe."
