### 912/914 emergency airworthiness directive

Safety Promotion Unit/Civil Aviation Authority of New Zealand

## Defect Report- Xair Hanmuan

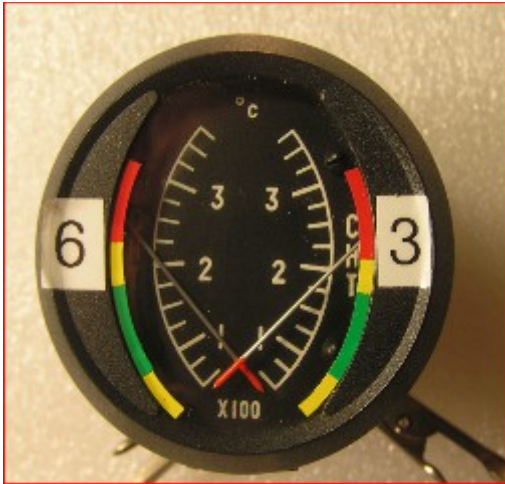
Alpi fitted a two channel cylinder head temperature gauge reading from 60deg to 360deg with sectors coloured green, yellow and red. The green covers 100deg to 180deg, yellow, 180deg to 220deg and red 220deg upwards.

One would assume then, that maintaining the cylinder head temperatures in the green would be safe. Not so. The manufactures state that the maximum continuous head temperature is 180deg (top of the green) and absolute maximum is 200 deg half way into the yellow.

That is a difference of *one division* on this gauge between max cont and abs max. Half of the scale would never be used (or shouldn't be). That gauge was useless! *<Ed- well not entirely useless, just not as useful as an expanded scale covering the operating area>*

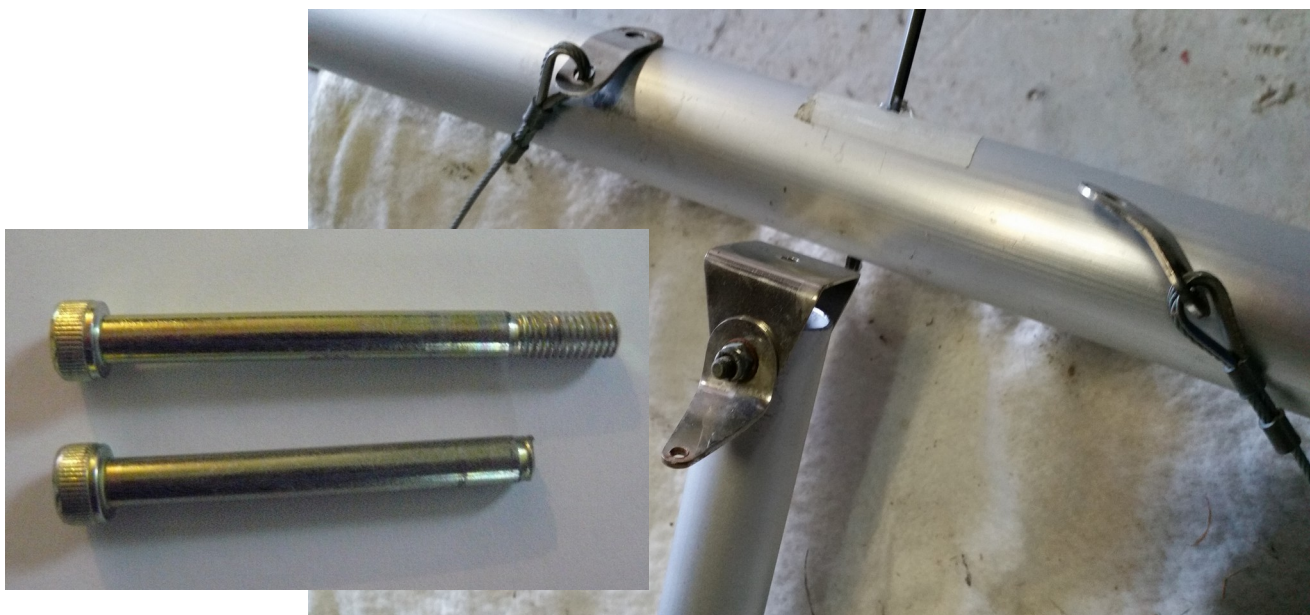
Defect Details	
Microlight type/model	Xair Hanuman MMC
Total Time in Service (hrs)	417 hrs
Defect area	Airframe/Engine/Controls/Flying surfaces/Undercarriage/etc
Describe the defect	<p>Issue found during a pre flight. Inboard Port rear brace wire and drag link attachment bolt broken at point of shank and thread. The bolt is a cap screw marked TVS 12.9. It would appear that during initial assembly the nut and washer have been wound up hard against the shank. Bolt has broken leaving inner brace and wires floating.</p> <p>Starboard wing subsequently removed and cover stripped for inspection. Bolt and nut found to be done up to a similar level of tension with obvious signs of marking</p>
Describe the affect on airworthiness	<p>Aircraft was grounded immediately on finding these problems. An engineer and IA checked the findings and agreed with our observations. Engineer supplied replacement bolts and washers.</p> <p>Pictures posted as a separate file.</p>

Remedial action taken	<p>Caps screw on both wings replaced with a slightly longer version allowing washers to be used as packers and spacers reducing drag wire tension slightly and allowing for the nut to be done up correctly without bottoming out on the shank.</p>
