February 2022

RAANZ RECPILOT

CARBURETTOR ICING

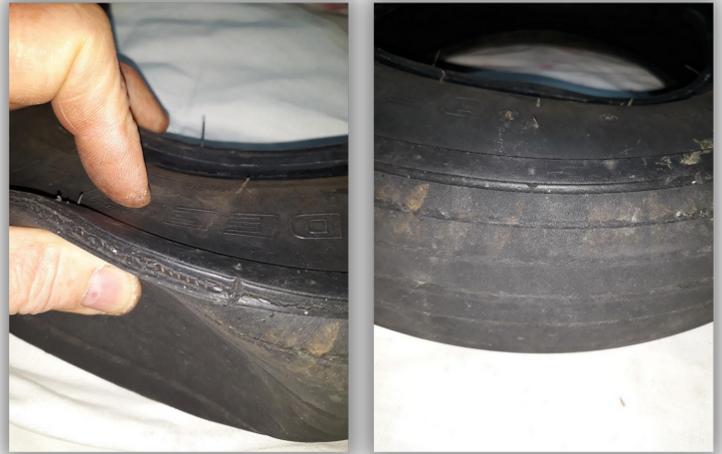
If your tires have been on for a few years, look hard to see if there is any split or cracks appearing. The pictures above are of a tire that was on an aircraft with an up to date annual, but the tire was shot. It looked ok from a distance apart from a bit bald but was about to go bang.

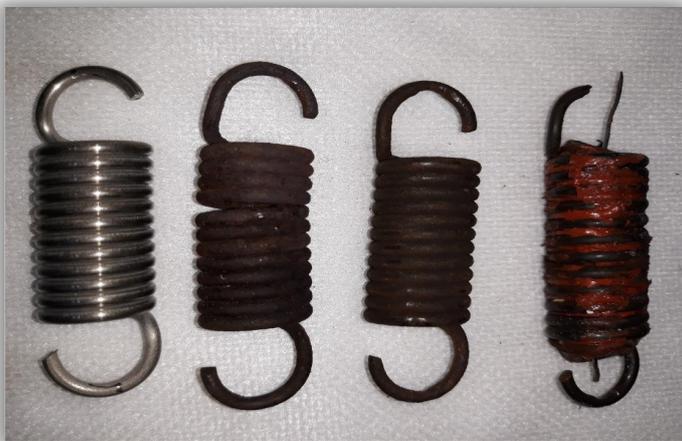
You will see in the picture below that the broken one has a tie wire through it and hi temp silicone over the wire and spring.

This simple job ensures in most cases that when the spring breaks at one end, it will remain in position and not head out through your prop. It will then be picked up at the next pre-flight. You will also note in the picture, the spring hook (eyelet) wear (that is very hard to see at pre-flight) is about to fail under spring tension.
